**PRELIMINARY MATERIAL TESTING OF CERAMIC
AND WOOD**Raymond W. Nethers
David W. Metzger

May 1986

Final Report

AIR FORCE WEAPONS LABORATORY
Air Force Systems Command
Kirtland Air Force Base, NM 87117-6008

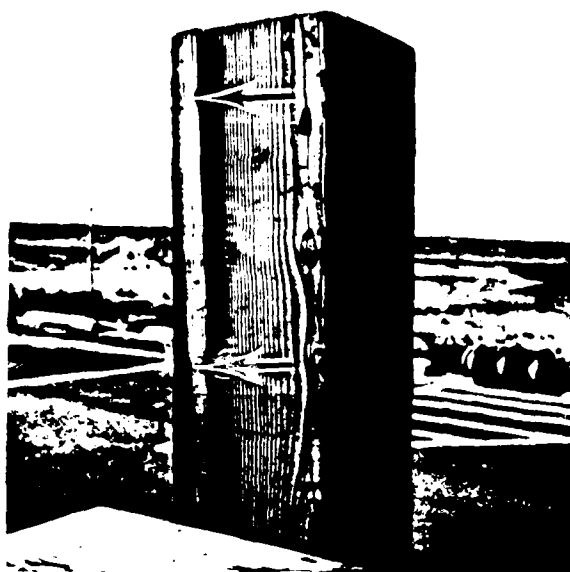
(a) Damage to upper part of post.

The flashovers tracked on the surface of the wood and through the split rings. Voltages just above flashover value caused no structural damage.

One pulser shot was made at 120 kV charge voltage (nominal 1.5 MV output). This shot caused considerable structural damage as a 1 by 1-in shard was ejected (Fig. 3).

Figure 3. Damage to TRESTLE wood joint post.
